# Manhole Inspection Summary

Manhole # S45E2\_013MH

**Location** Address: **3909 Popland St.** Cross Street: **Pennington Ave.**

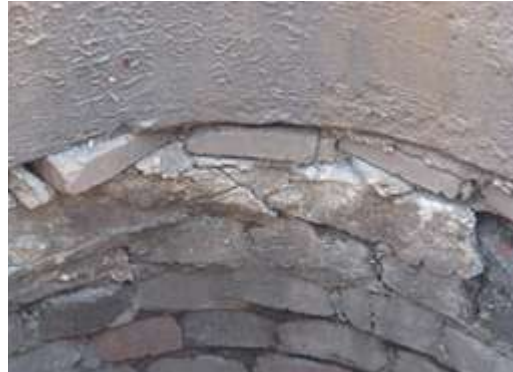
Defect 1

**Chimney / Frame Adjustment** ☒ Exists Material: **Brick** ☐ Parged Height: **4** (in.)  
Condition: ☐ Sound ☐ Cracked ☐ Root Intrusion ☒ **Loose Brick** ☐ Deteriorated  
Infiltration: ☐ None ☒ **Joint** ☐ Cracks ☒ **Mortar** ☐ Roots ☐ Wall

Chimney infiltration

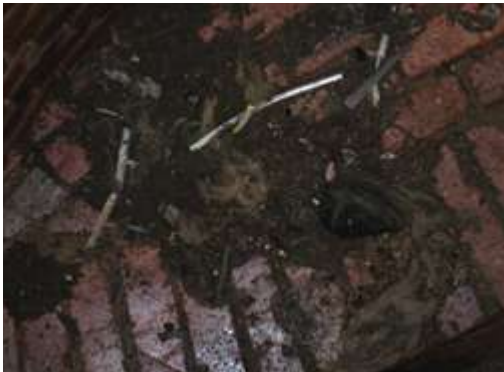
Defect 2

Debris/trash on bench

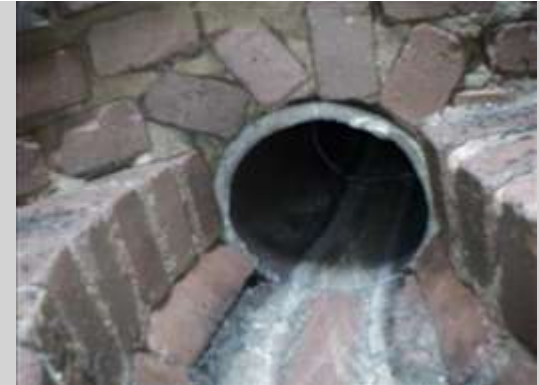
12 O'Clock Outflow

8 in. Circular Gravity Sewer  
Pipe Out @ 12 O'Clock

Pipe Height: **9.6** (in.) Rod and Bar (Angled)  
Pipe Material: **Clay** ☐ Pipe Lined  
Invert Depth: **10.45** (ft.) Flow Characteristics: **Fast**  
Deposits: ☒ None ☐ Mud ☐ Sludge ☐ Debris ☐ Grease  
Silt Depth: (in.) Deposits Extent:  
Infiltration: **None** Pipe Seal Cond: **Sound**

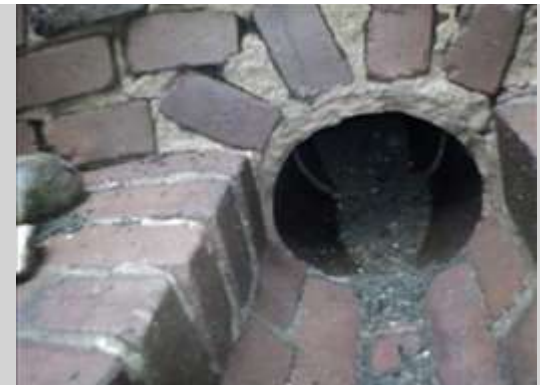
3 O'Clock Inflow

8 in. Circular Service Sewer  
Pipe In @ 3 O'Clock

Pipe Height: **9.6** (in.) Rod and Bar (Angled)  
Pipe Material: **Clay** ☐ Pipe Lined  
Invert Depth: **10.18** (ft.) Flow Characteristics: **None**  
Deposits: ☒ None ☐ Mud ☐ Sludge ☐ Debris ☐ Grease  
Silt Depth: (in.) Deposits Extent:  
Infiltration: **None** Pipe Seal Cond: **Sound**

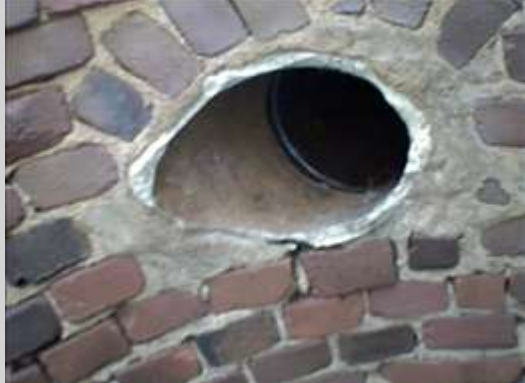
5 O'Clock Inflow

Pipe In @ 5 O'Clock

Pipe Height: **9.6** (in.) Rod and Bar (Angled)

Pipe Material: **DIP/CI** ☐ Pipe Lined

Invert Depth: **7.97** (ft.) Flow Characteristics: **Fast**

Infiltration: **None** Pipe Seal Cond: **Sound**

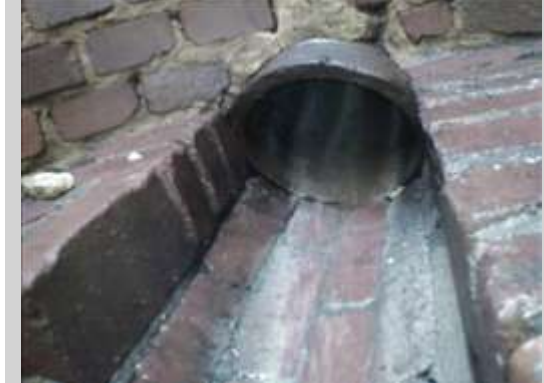
Drop In @ 5 O'Clock

Drop: <b>Outside</b>	Rod and Bar
Angled: <b>Yes</b>	Reading: <b>9.53</b> (ft.)
	Inv Depth: <b>10.53</b> (ft.)
Drop Condition: <b>Open</b>
